Sunrise Park and Beach Waterfront Master Plan

Lake Bluff Park District

Anticipated Adoption January 27, 2014

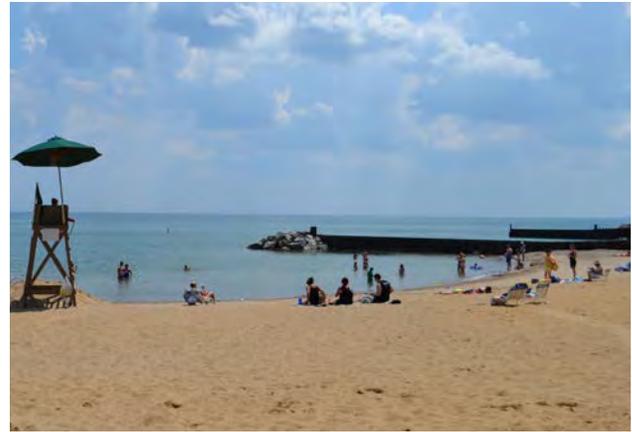
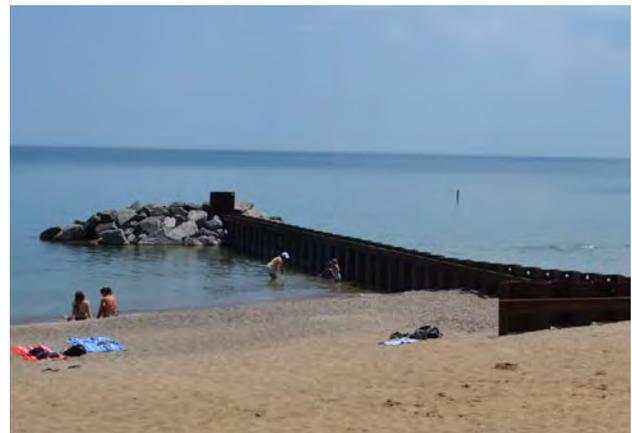
In order to maintain sand on the beach and reduce wave action, coastal groins extending into the lake are strategically located. These are made up of corrugated steel, rock, or a combination of the two. The various groins range in condition. Most of the stone groins are in good condition, however most of the steel groins have holes worn through them.

Recommendation:
The groins should be reviewed for current condition. Action should be taken to ensure continued protection of the beach through the groin system.

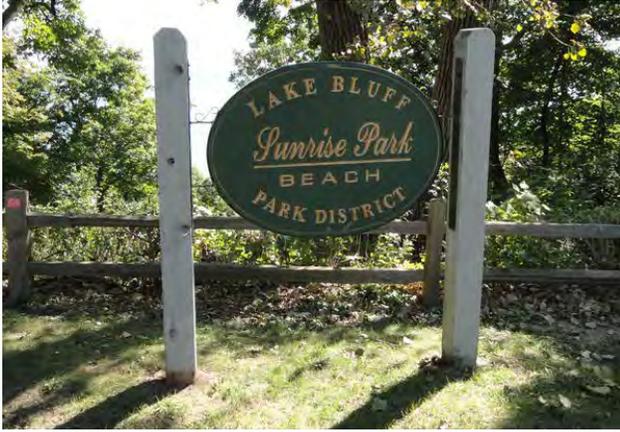
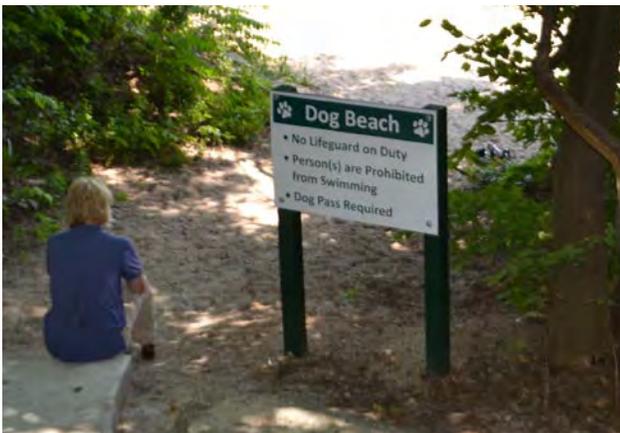
Existing Signage

At Central Avenue, a site sign welcomes patrons to one of the main entrances. A safety and regulation sign is also at the top of the bluff. This sign identifies when lifeguards are on duty and the swimming conditions. This sign is not particularly clear on swimming conditions.

Recommendation:
The swimming condition should be replaced with an updated sign. An additional sign should be placed at the other entrances to the beach along the top of the bluff and all signage on site should be reviewed to create a congruent and welcoming message.

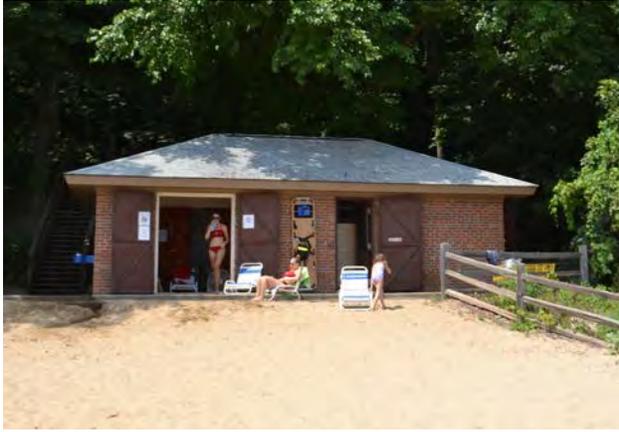
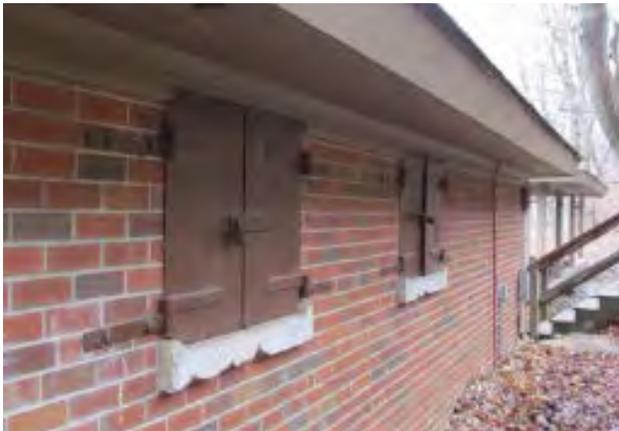
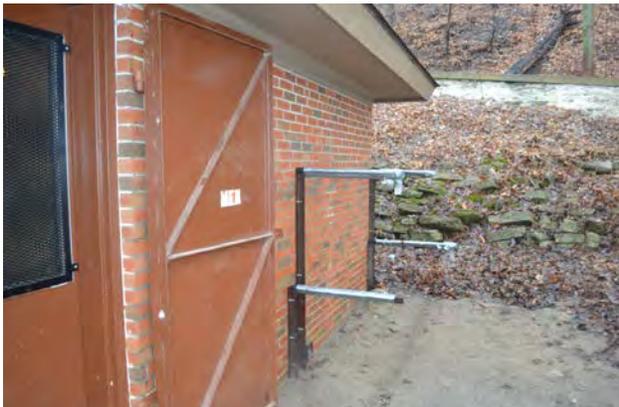
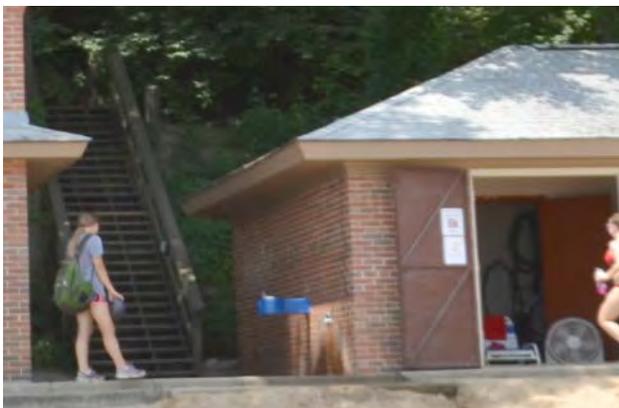
Restroom and Storage Building

The restroom and storage building is a one story residential style building with a hipped roof with cedar fascia and soffit and standard three tab architectural shingles. The west end of the building is partially built into the hillside and the east side faces Lake Michigan. There are two small windows on the west side of the building, two doors on the east side, and one door on the north side. The building has no particular architectural style, and it does not reflect the character of the neighborhood.

The roof is in average condition, and while the shingles are stained and rather old looking, they do not appear to be in danger of failing. It appears the building has been re-roofed, as there are some areas where another layer of shingles underneath this roof can be seen. The cedar fascia and soffit on all four sides of the roof is in very good condition, and appears to have been recently repainted.

On the outside of the building, all of the original doors and windows have had sheet steel doors or window covers fabricated and installed over the original openings, and they have been anchored directly into the face brick. The condition of these door covers is very poor, as they are dented, rusty and generally beat up. Aesthetically, they detract from the appearance of the building and have an industrial look that is not appropriate for a building of this type.

There are two toilet rooms in this facility, and the condition of these two rooms is identical. The exterior walls and some of the interior dividing walls are yellow glazed concrete block. The interior wet walls are covered with Fiberglass Reinforced Plastic (FRP) panels which is not very attractive. There are a couple of fluorescent lights on the ceiling and an exhaust fan can be heard when operating.

The condition of the plumbing fixtures is average for a building of this age. The floor itself is an epoxy coating over the concrete slab which has worn off in many locations. The lavatory countertop is a solid surface material which is in fairly good shape.

There are two main concerns with the toilet rooms. First, the condition of the toilet rooms themselves is very unappealing in terms of general finishes, colors and condition. Second, the toilet rooms are not ADA accessible. There is no accessible toilet, urinal or sink, and the entry sequence into each room is very tight and does not provide the required maneuvering clearances. Due to the small size of each room, in order to remodel them and make them accessible, one toilet would have to be removed in order to provide the proper size facility. If an option is to renovate this building, both toilet rooms should be currently gutted and remodeled to ADA compliant facilities.

Recommendation:
Based on the assessment of this building, it is possible to renovate the building to bring it up to current standards. However, the building is so small, and lacks architectural character, so another option for consideration would be to build a new building, in an appropriate style, that provides the necessary space and facilities and represents the character of Lake Bluff.

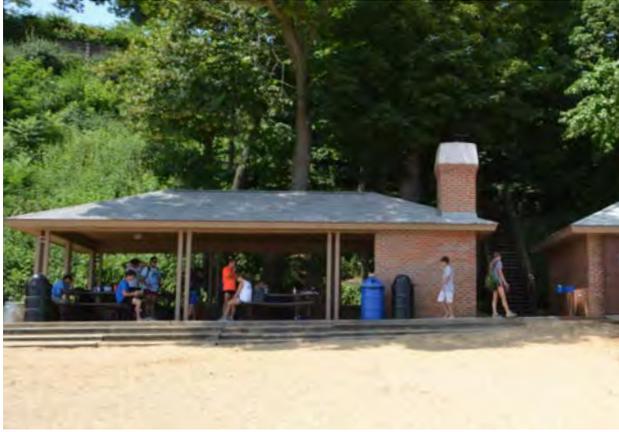
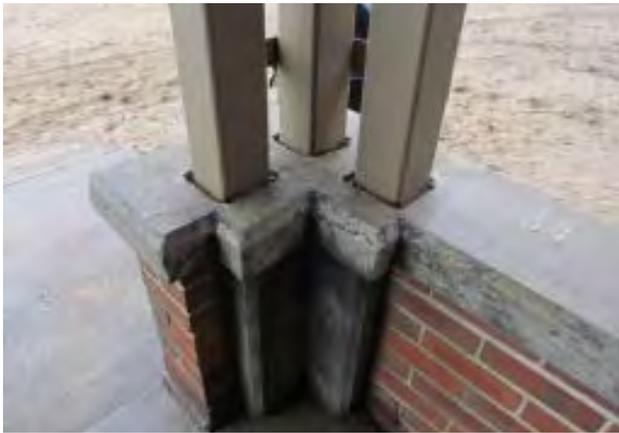
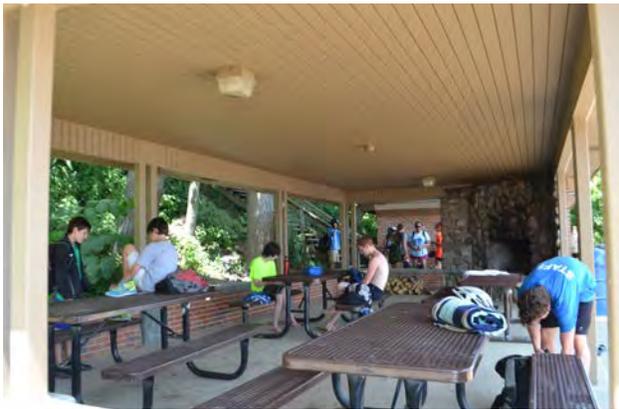
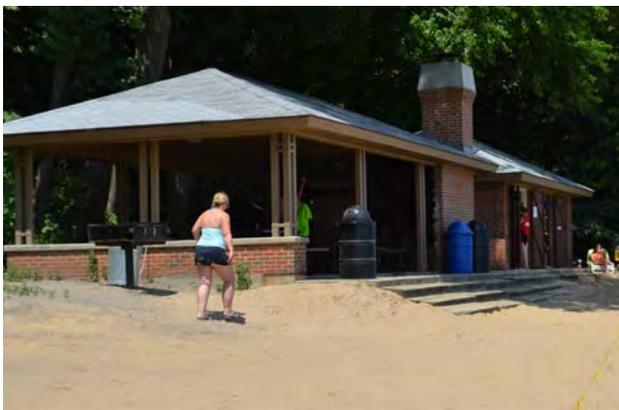
North End Picnic Shelter

The construction of the picnic shelter is very similar to the restroom and storage building. It uses the same brick, roof structure, shingles, fascia and soffit. However, this building has a perimeter partial height wall around three sides of the building, and the east side is completely open to the lake. There is an exposed concrete slab, which is in generally good condition. The stone fireplace in the corner of the building is in generally good condition, although it would benefit from a good cleaning.

The condition of the brick around this building is very similar, with the same amount of cracking and broken bricks. On top of the partial height brick walls is a concrete sill which is in average to slightly below average condition, with some cracking. It would benefit from a good cleaning.

The columns supporting the roof structure are 4" square painted steel columns in pairs, except for at the corners, where they are grouped in three. Their condition is very good, and they appear to have been recently painted.

The underside of the ceiling is 4' x 8' sheets of grooved plywood, painted to match the fascia and soffit, and is in generally very good condition. There are two light fixtures mounted to the underside of the ceiling, which are not particularly attractive.

The main concern of this facility is that, like the building to the north, there is no architectural style to this building. These two buildings together appear to be nothing more than simple brick boxes with hipped roofs on top. While there are no imminent concerns on this facility regarding structural integrity, we feel that for a park and as special as Sunrise Park, something more in keeping with the architecture of Lake Bluff should be implemented.

A functional concern regarding these buildings is the fact that there is not ADA accessible route to get to the buildings from the parking lot.

The North Shelter, South Shelter and Restroom should meet current accessibility standards including a route to each.

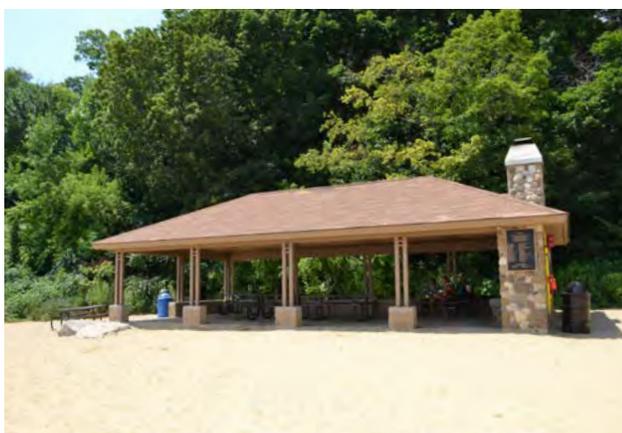
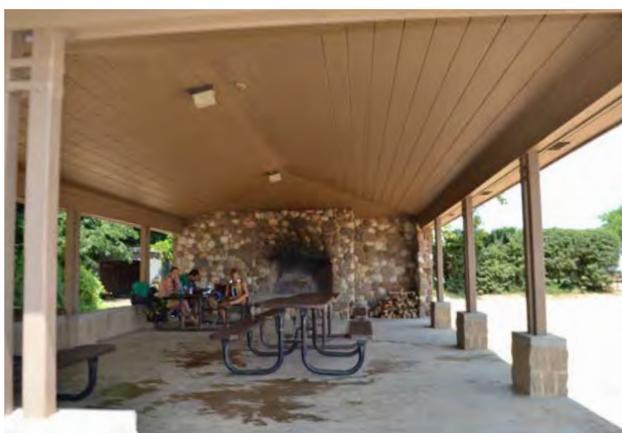
South End Picnic Shelter

The South shelter was built in the 1990's and is generally in very good condition. The style is similar to the north shelter and includes a large fireplace. Like the north shelter, the back wall is a knee wall and there is no ADA accessible route to access this shelter. No rest rooms existing at the south beach.

If toilet facilities are desired at the south end, it is recommended that a new, separate facility be constructed on this portion of the beach.
