Sunrise Park and Beach Waterfront Master Plan

Lake Bluff Park District

Anticipated Adoption January 27, 2014

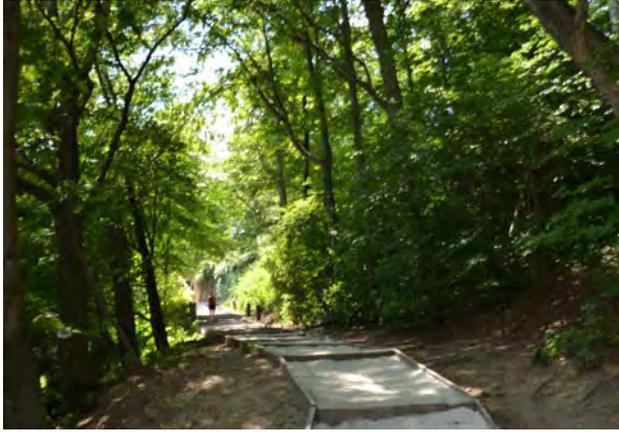
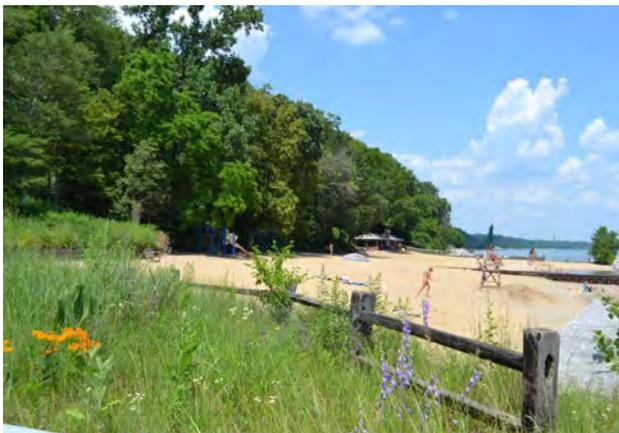
Bluff and Native Plantings

Native planting along the bluff are a necessity to the health of the bluff system. There are various vegetative communities represented between the tableland at Sunrise Avenue and the beach. Seventy-six feet of grade changes creates the bluff that Lake Bluff is named for.

A Bluff Vegetative Management Report was created by P. Clifford Miller and Associates in 2012-2013. The report identifies major woodlands, mesic forest and meadows located on the bluff with an extensive review of each vegetative community. As part of the report, suggested vistas along Sunrise are identified that fit with the site and vegetation.

At the base of the bluff near the NSSD building, the Lake Bluff Open Lands Association (LBOLA) maintains a native prairie and beach grass area. The Waterfront Master Plan incorporates both the LBOLA area and the Bluff Vegetative Management Report as part of the overall plan.

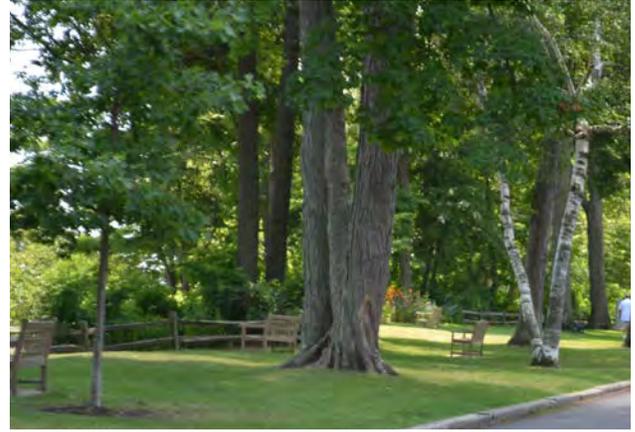
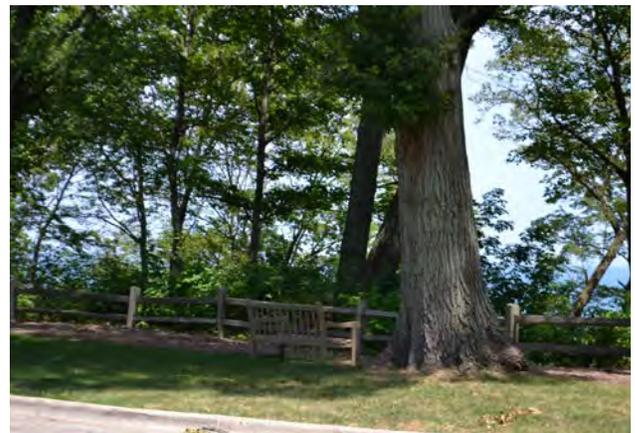
Tableland and Mulch Trail

Along Sunrise Avenue between the road and the edge of the bluff, there is a large lawn area with deciduous trees creating a shaded park area. The area, called the tableland, is used for viewing the lake, weddings, events and general park play.

At the edge of the bluff, a mulch path runs along Sunrise Avenue and the tableland. There are twenty-three memorial benches scattered along the trail. Additionally, a bike rack, rail fence and signage can be found along Sunrise Avenue.

Overall the park has a worn look along Sunrise Avenue.

Add landscaping to improve the look, designate locations for entry signage, do not allow any additional memorial benches, and group benches where possible.

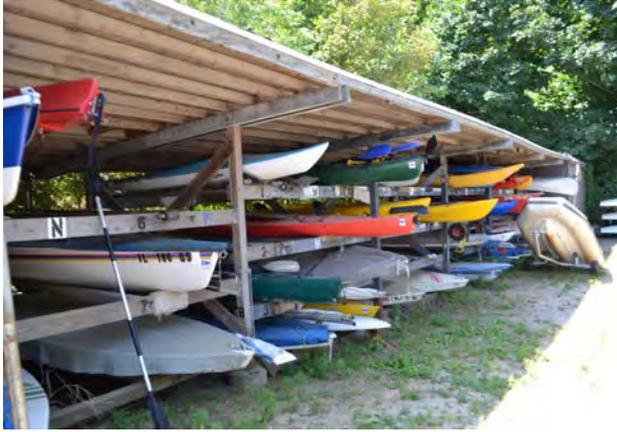
Lake Bluff Yacht Club is a private member based Sunfish sailing club. It provides sailing programs, including racing instruction, family participation, and social activities. Located south of the NSSD building, the Yacht Club has primary access to the lake on the south beach as designated by a sign. The Yacht Club leases the property which is owned by the Village.

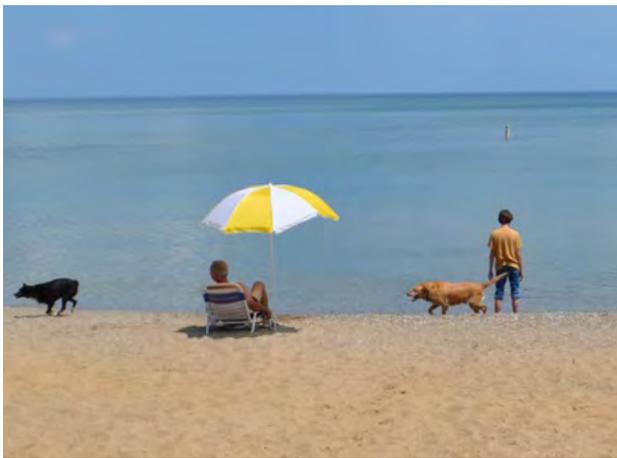
Dog Beach

Located at the northern edge of the existing beach, the designated dog beach area allows visitors to bring their canine companions to enjoy the lake. This area is gated at the south with a split rail fence and has signage posted with the rules and regulations. North of the dog beach is an area of stone and concrete rubble which is part of the site but currently un-welcoming for beach use. The beach sand is more gravelly at the dog beach than other beach locations making it less desirable.

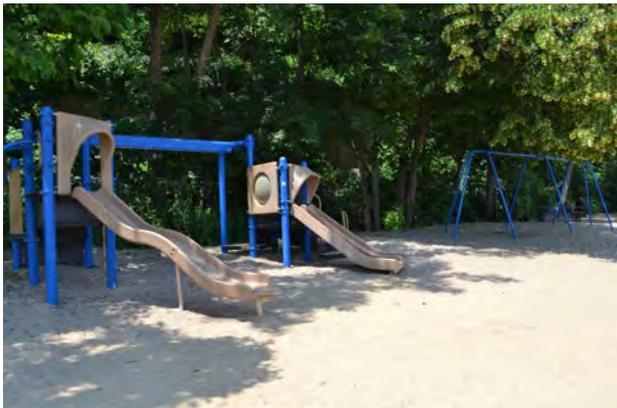
Playground

The playground area is located just north of the NSSD building and centrally located along the beach. Close to the toe of the bluff, there is no designation between the playground area and beach. The playground surfacing which is beach sand, does not meet current standards. The playground is at an age where replacement is desired.

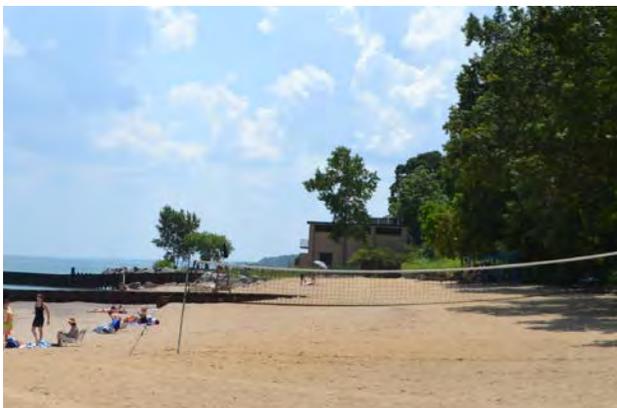
Sand Volleyball Court

One sand volleyball court is centrally located on the beach and oriented north-south. The court is available for use on a first come, first serve basis unless it is scheduled for a tournament. The posts are aluminum and along with the net, they are showing signs of wear.

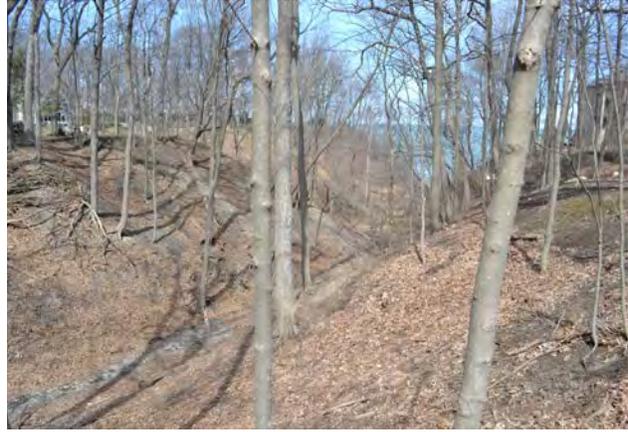
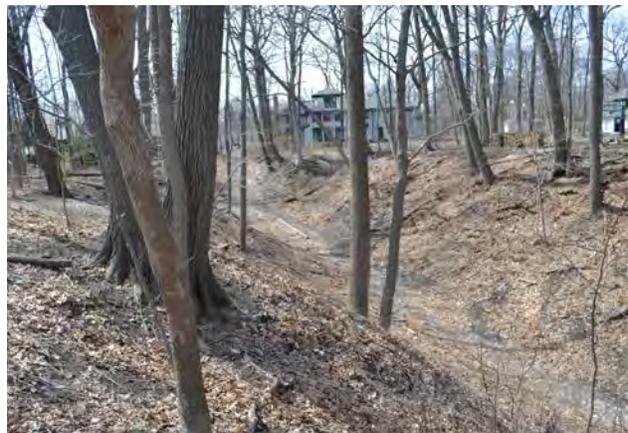
Ravine

Adjacent to the northern end of the park, there is a ravine between the bluffs. There is an easement in the middle of the ravine that is owned by the Village and the slope of the ravine on either side is privately owned. A foot trail can be seen at the bottom of the ravine, however it is not marked as a trail. Residents use this ravine as a rail to the lake front.

Recommendation:
Pursue the possibility to create a formal agreement between the Village and the Park District for permanent access to Sunrise Park and Beach using the ravine.

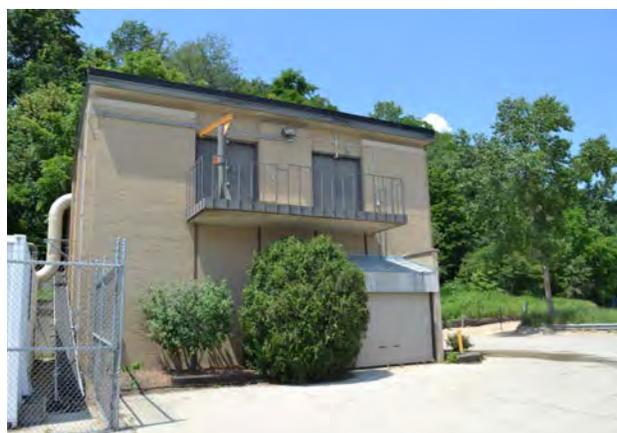
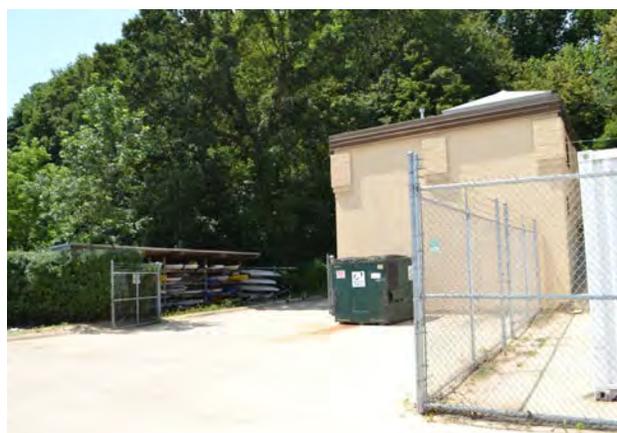
Existing Sanitary Pumping Station

Between the beach at the north end and the south end, at the bottom of the driveway leading down from the bluff, a existing which is owned by the North Shore Sanitary District (NSSD). The building itself is a simple, utilitarian two story flat roofed brick building with no architectural style at all. Its location, between the two ends of the beach, is less than desirable, as visitors to the beach need to walk past it, through the parking lot, to get to one end of the beach to the other. There is no option to relocate the building.
